**NL INDUSTRIES/TARACORP SUPERFUND SITE GROUP**  
**Leed Environmental, Inc.**  
**Van Reed Office Plaza**  
**2209 Quarry Drive, Suite C-35**  
**Reading, PA 19609**  
**Telephone: (610) 670-7310**  
**Facsimile: (610) 670-7311**

November 19, 2019

**Re: NL Industries/Taracorp Superfund Site; Granite City, Illinois**  
**Second 2019 Semi-Annual Operation and Maintenance Inspection (November 2019)**

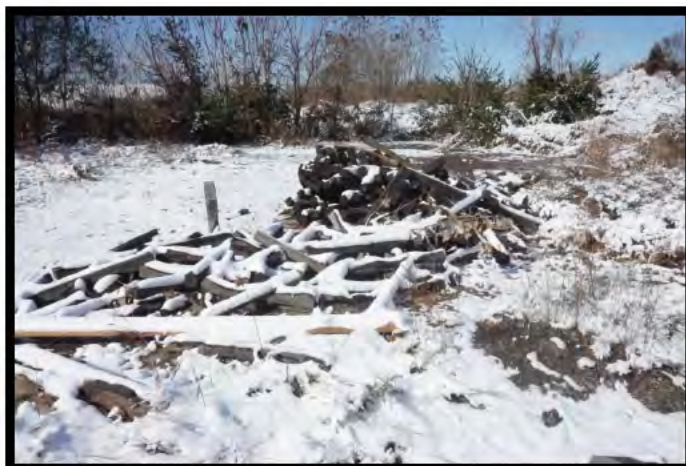
Photograph 11: Slough Road, foundation of former Robin's Nest Lounge.

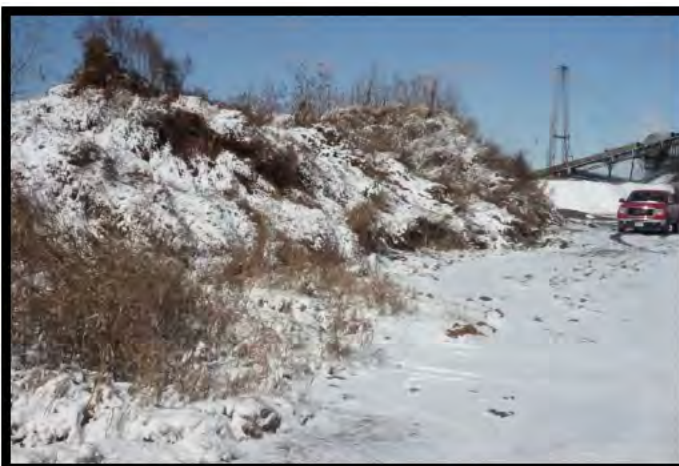
Photograph 12: Slough Road, soil pile near foundation of former Robin's Nest Lounge.

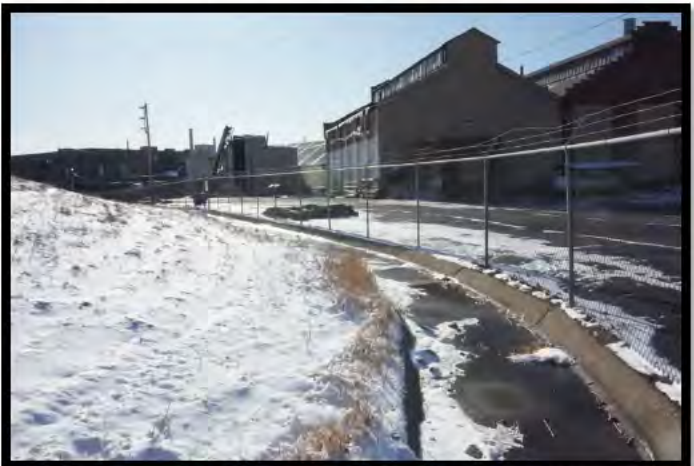
Photograph 16: Concrete drainage swale, crack in concrete along northwestern side of Taracorp pile.

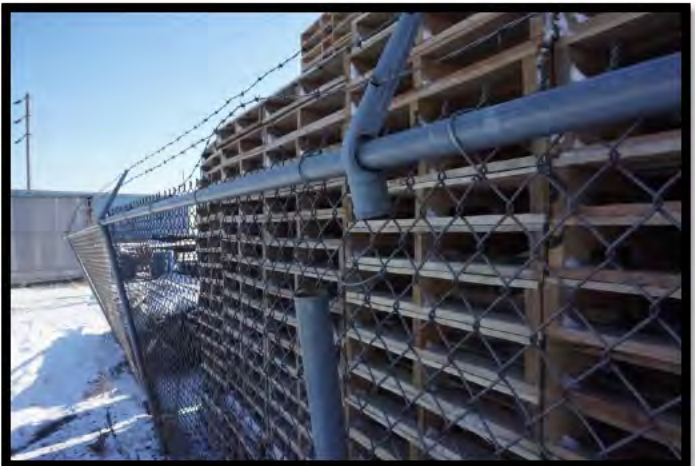
Photograph 40: Broken fence pole (material staging on State Street Warehouse property).

- The Group has notified the owner/operator of All Pallet Services, one of the companies that operates on the neighboring property, and has requested that All Pallet Services repair a bent section of fence and a separated fence post (Attachment 5, photographs 40-42).

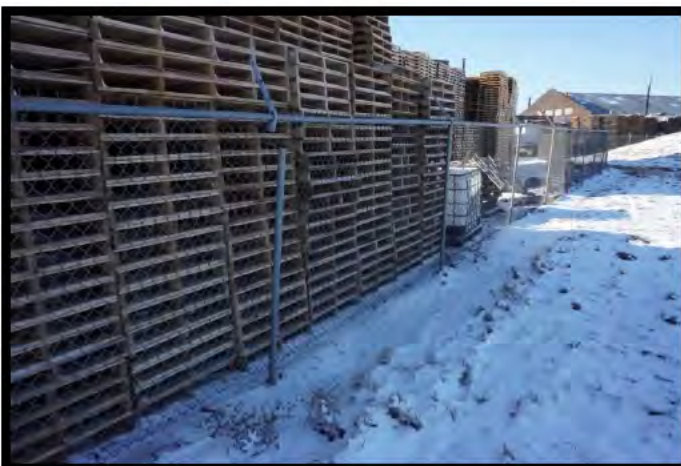
Photograph 41: Broken fence pole (material staging on State Street Warehouse property).

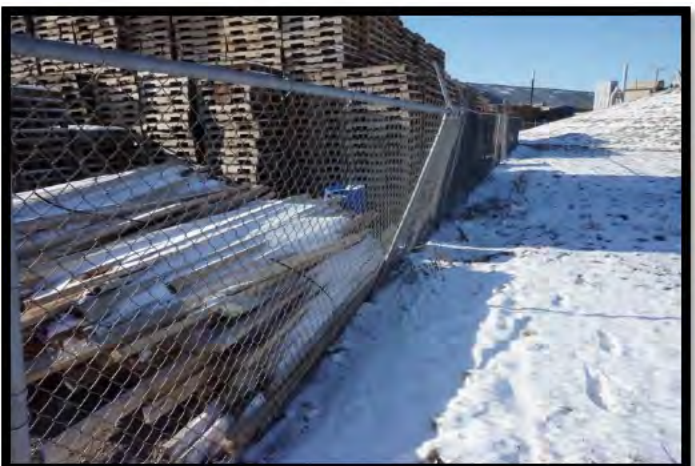
Photograph 42: Broken fence pole (material staging on State Street Warehouse property).

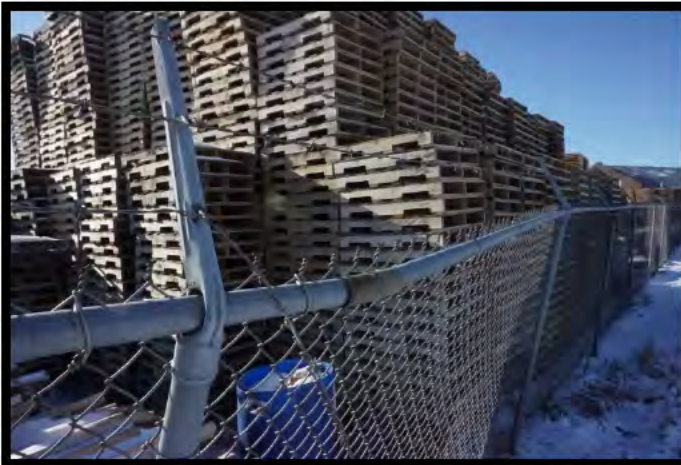
Photograph 43: Bent fence and broken barbed wire (material staging on State Street Warehouse property).

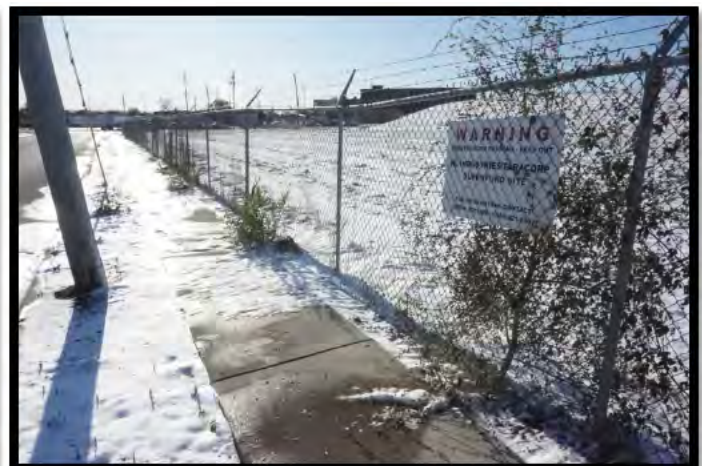
Photograph 72: Warning sign along State Street.

- The Group has requested that its lawn maintenance contractor, Munie Greencare Professionals, cut and remove several bushes along the sidewalk and remove some vegetation from the fence along State Street (Attachment 5, photographs 72-76 and 79).

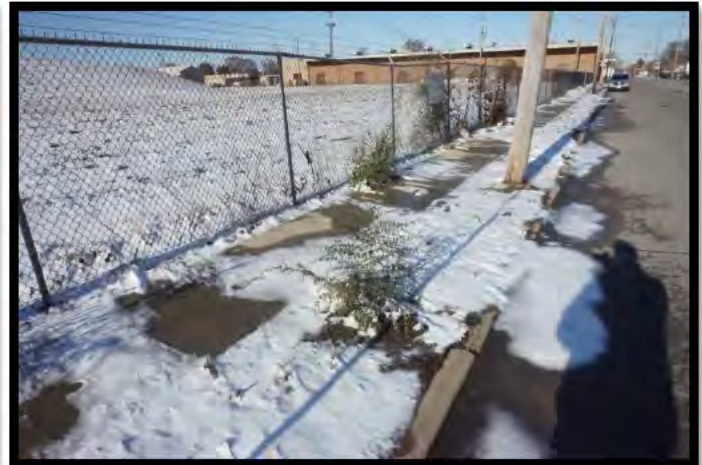
Photograph 74: Sidewalk along State Street.

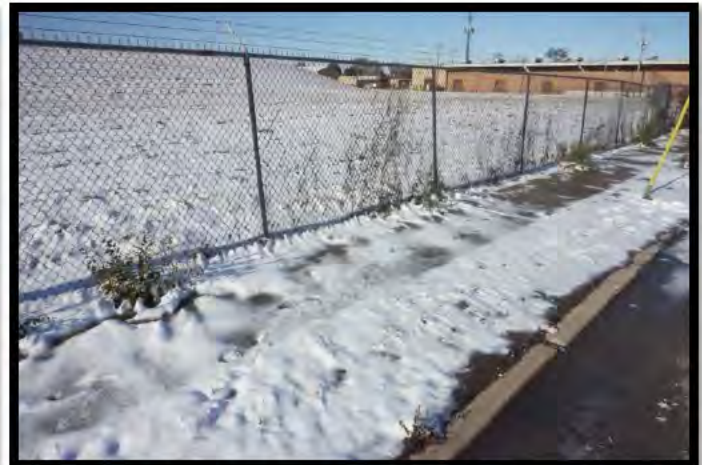
Photograph 76: Vegetation along State Street sidewalk.
